**WROCLAW UNIVERSITY OF SCIENCE AND TECHNOLOGY
FACULTY OF MECHANICAL**

REPORT series report No. 94/2020

RESEARCH OF PORTABLE DATA STACK HOLDER

Principal: Cryptosteel® by Sword LTD, Wrocław, November 5, 2020, registered at the Department of Vehicle Engineering at the Wrocław University of Technology under No. 164/4102/0022/20.

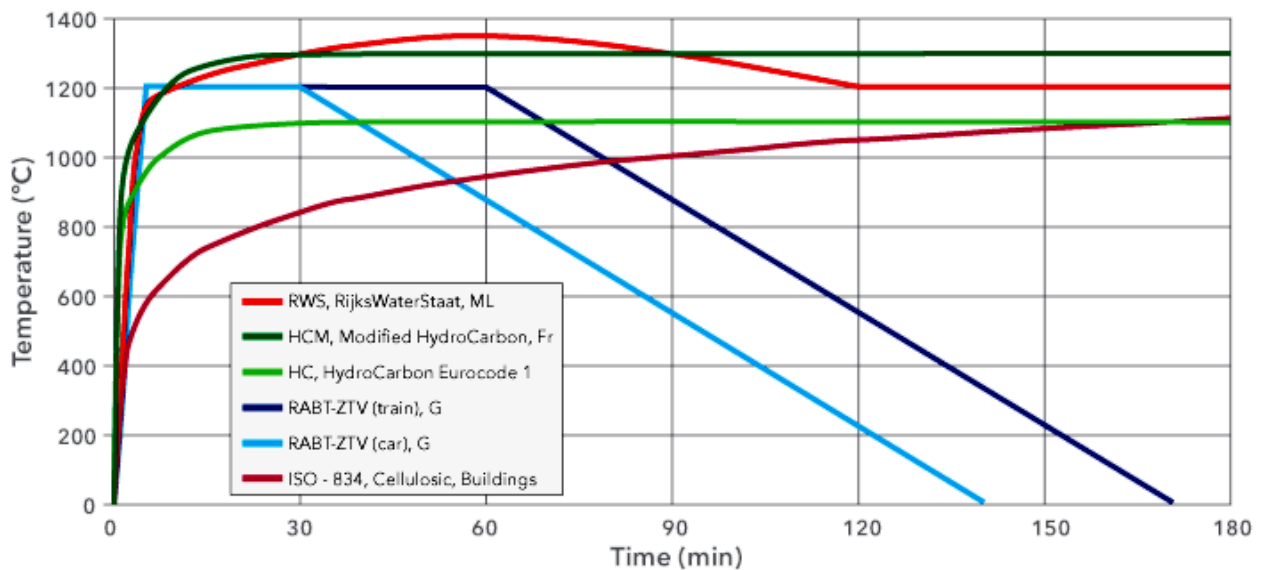
Figure 1.1. International fire development curves in fire tests

Fire development curves can be designed for each room in the building, which show the temperature course over time (Fig. 1.1). Such curves are a useful tool for building fire safety and fire safety design. During fire tests, building and vehicle elements are subjected to a thermal load which is determined by the standard fire development curve.

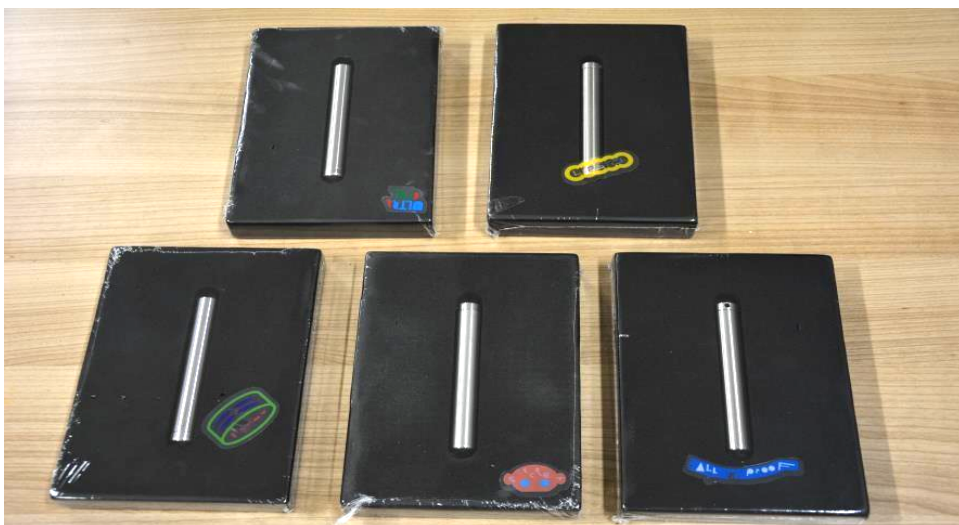
Figure 3.1. General view of the delivered test samples

The subject of the research were Cryptosteel capsules made of austenitic acid-resistant steel of AISI 303 grade (outer casing) and AISI 304 (core, tiles, separators, fasteners) (Figs. 3.1-3.3). After laboratory fire tests, the capsules were subjected to macroscopic observation using the OPTA-TECH stereoscopic microscope.

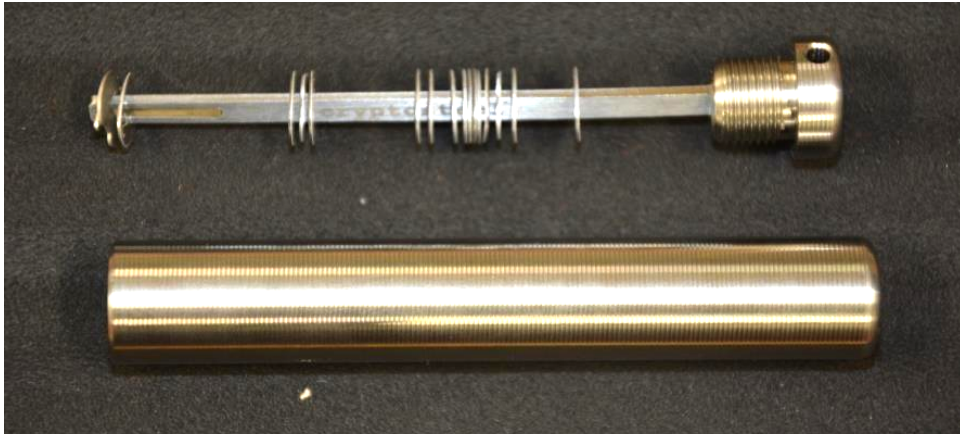
Figure 3.2. General view of the Cryptosteel capsule, visible outer casing and the core with tiles and separators

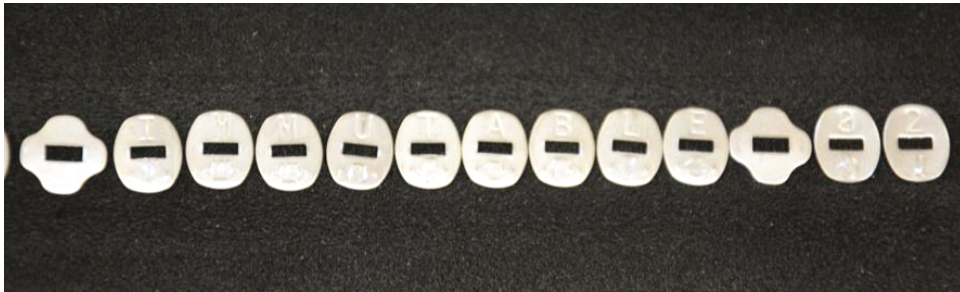
Figure 3.3. General view of the tiles with visible embossed letters

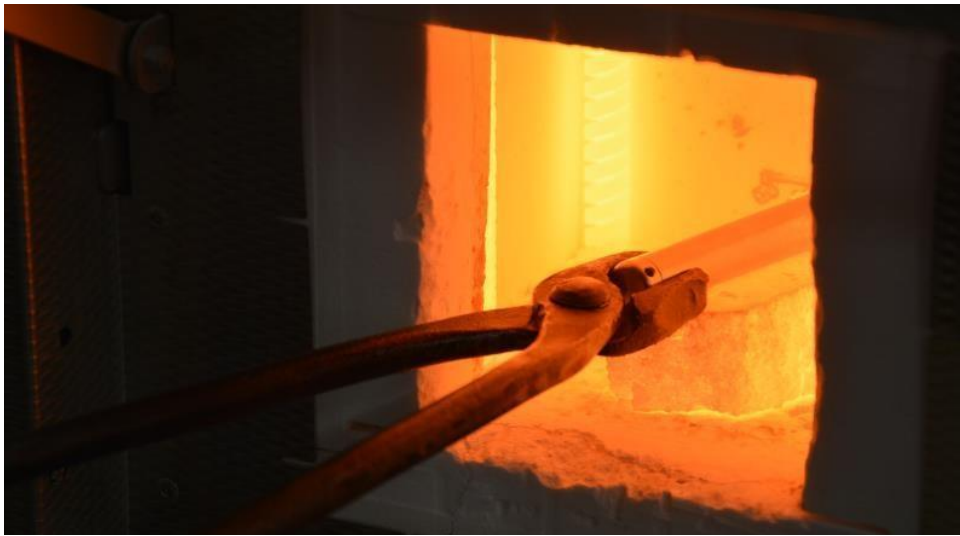
Figure 4.1. General view of sample No. 02 in the furnace at 1100 ° C

The laboratory fire test of the Cryptosteel capsule No. 02 was carried out at 1100 ° C for 60 minutes (Figures 4.1 and 4.2). Macroscopic observations immediately after the fire test showed that the capsule surface had oxidized but did not lose its continuity (Fig. 4.3). Moreover, it has been found that it is possible to open the sample by unscrewing the nut, but a great force is required to do so. Observations of the capsule core showed no thermal damage to the elements and that it was possible to read the information written on the tiles inside the capsule (Figures 4.4 and 4.5).

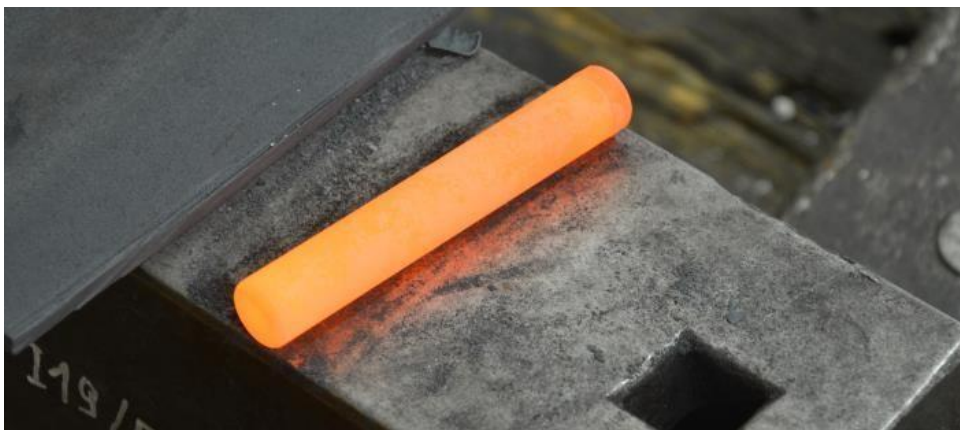
Figure 4.2. General view of sample No. 02 after its removal from the furnace at 1100 ° C

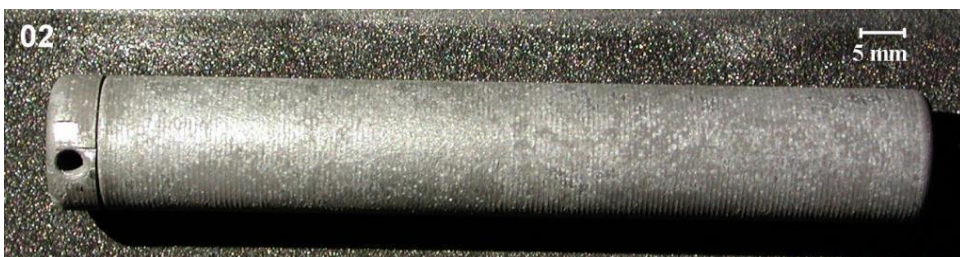
Figure 4.3. General view of sample No. 02 after fire test at 1100 ° C, visible oxidation of the outer casing surface

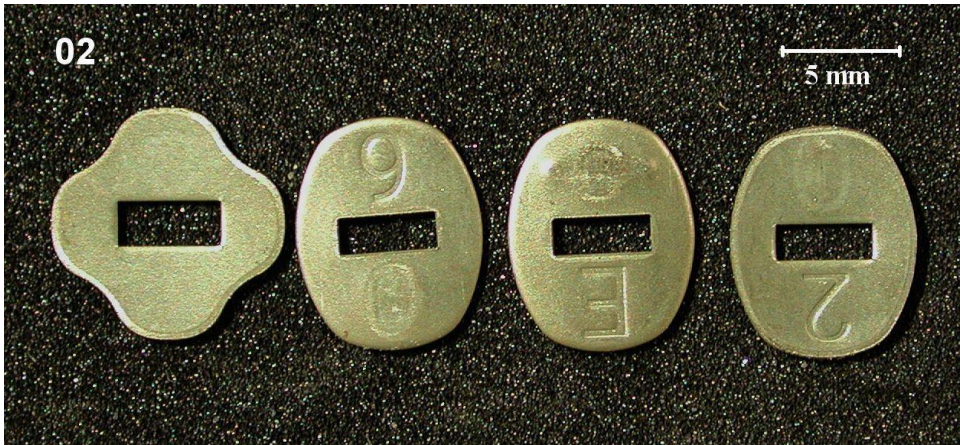
Figure 4.5. Tiles from the core of sample No. 02, no thermal changes in the material, visible embossed letters and numbers

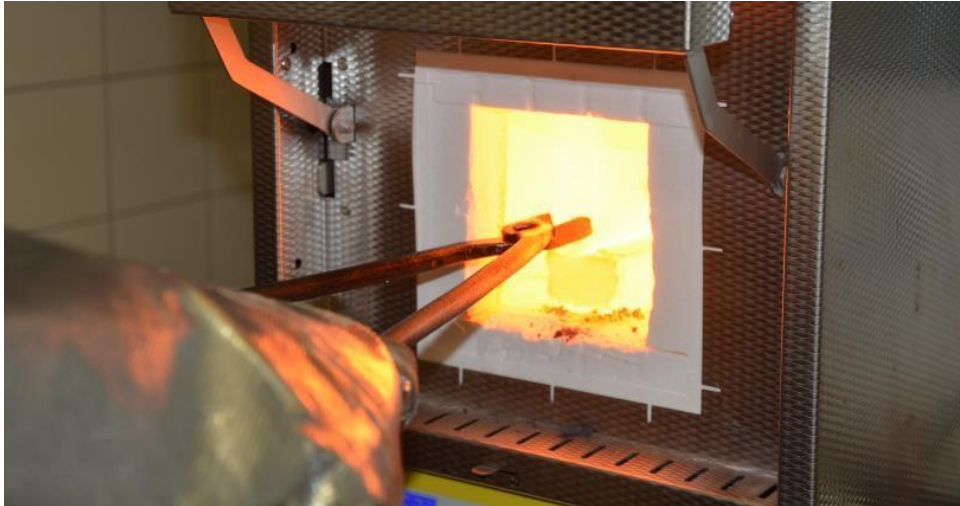
Figure 4.6. General view of sample No. 05 in a furnace at 1200 ° C

The laboratory fire test of the Cryptosteel capsule No. 05 was performed at 1200 ° C for 60 minutes (Figs. 4.6 and 4.7). Macroscopic observations immediately after the fire test showed that the capsule surface had clearly oxidized and peeled off (Fig. 4.8). Moreover, it was found that it was impossible to open the sample by unscrewing the nut, it was necessary to use a cutter. Observations of the capsule core showed thermal deformation of the stem and no thermal damage to the remaining elements (Fig. 4.9). It was possible to read the information written on the tiles inside the capsule (Fig. 4.10).

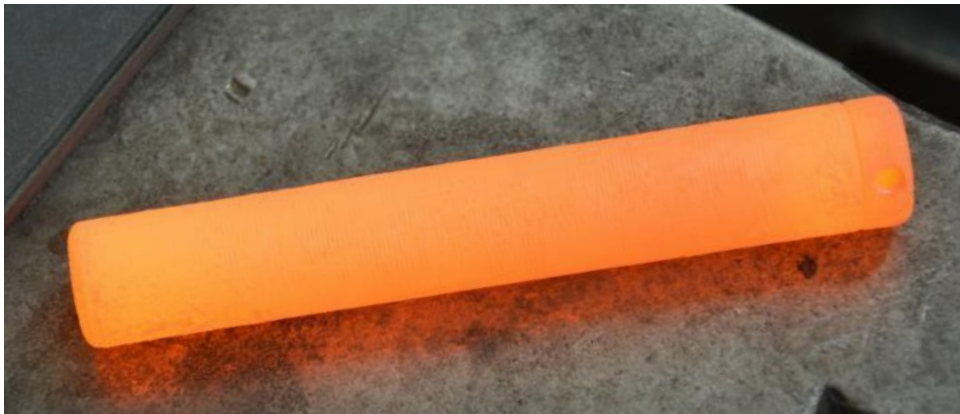
Figure 4.7. General view of sample No. 05 after removal from the furnace from the temperature of 1200 ° C

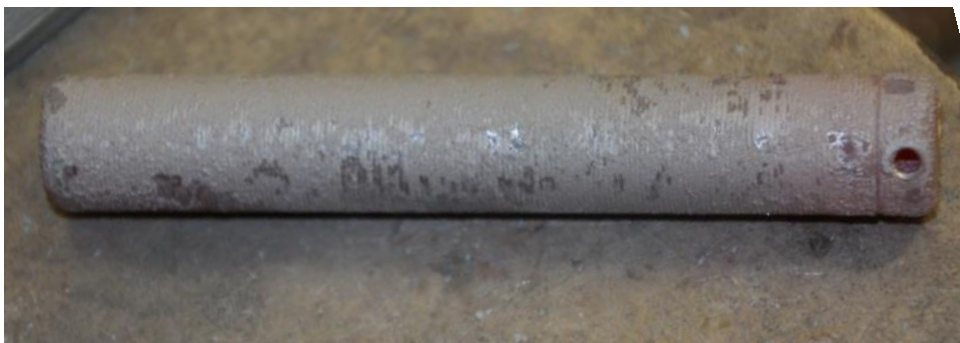
Figure 4.8. General view of sample No. 05 after the fire test at the temperature of 1200 ° C, visible oxidation of the outer casing surface.

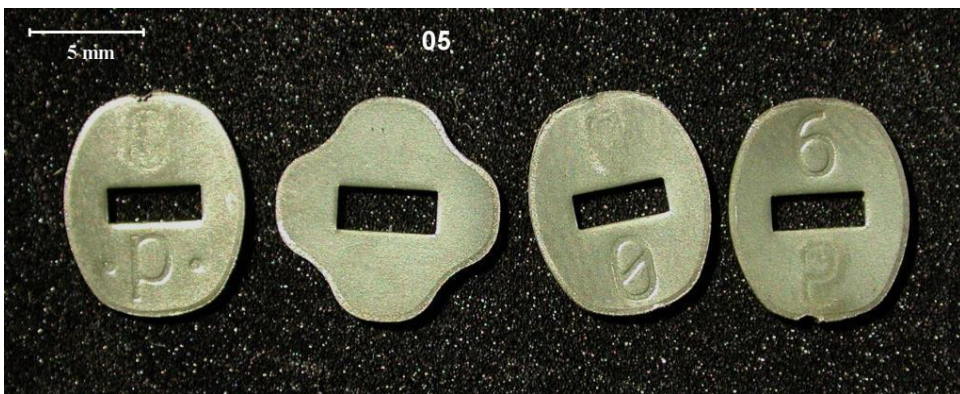
Figure 4.10. Tiles from the core of sample No. 05, no thermal changes of the material, visible embossed letters and numbers.

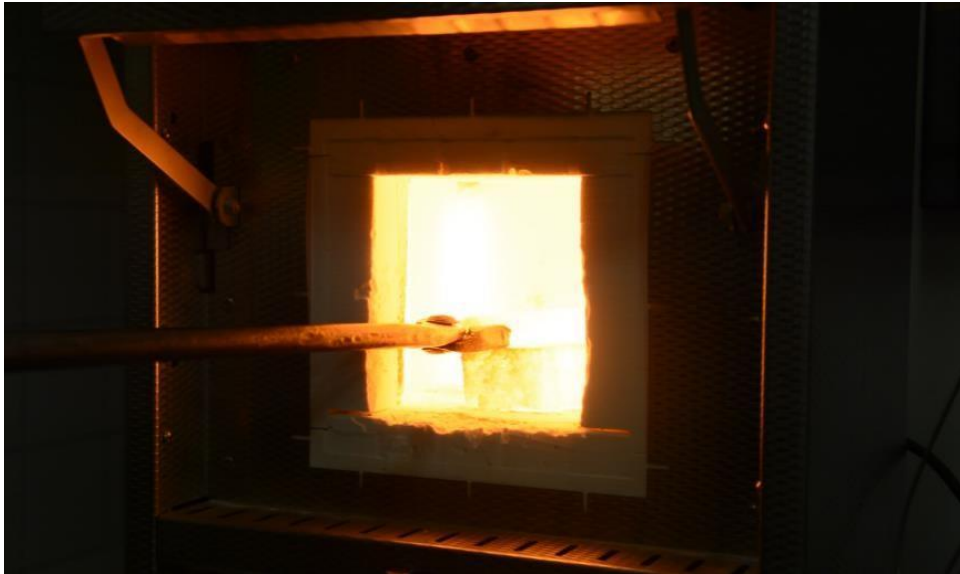
Figure 4.11. General view of sample No. 01 in a furnace at 1300 ° C

The laboratory fire test of the Cryptosteel capsule No. 01 was carried out at 1300 ° C for 60 minutes (Figs. 4.11 and 4.12). Macroscopic observations immediately after the fire test showed that the capsule surface was strongly oxidized and the surface layer delaminated (Fig. 4.13). Moreover, it was found that it was impossible to open the sample by unscrewing the nut, it was necessary to use a cutter. Observations of the capsule core showed thermal deformation of the stem and no thermal damage to the remaining elements (Fig. 4.14). It was possible to read the information written on the tiles inside the capsule (Fig. 4.15).

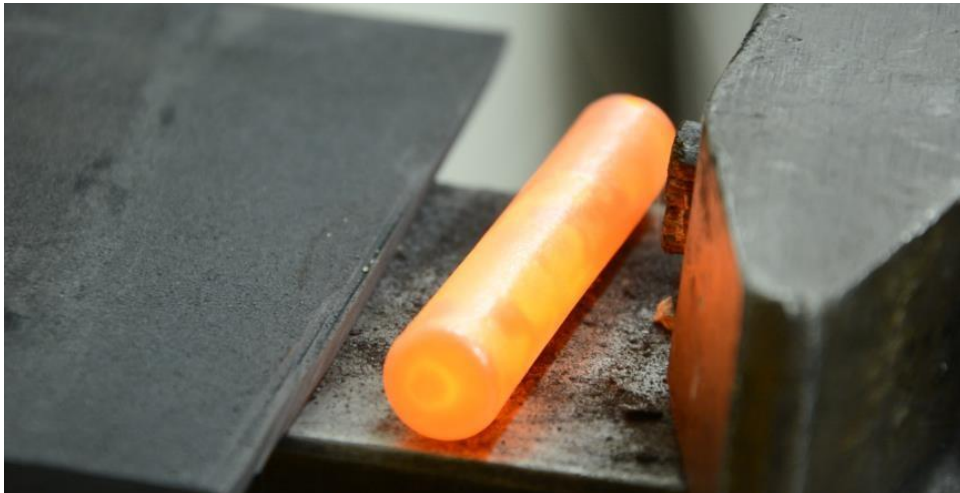
Figure 4.12. General view of sample No. 01 after its removal from the furnace at the temperature of 1300 ° C

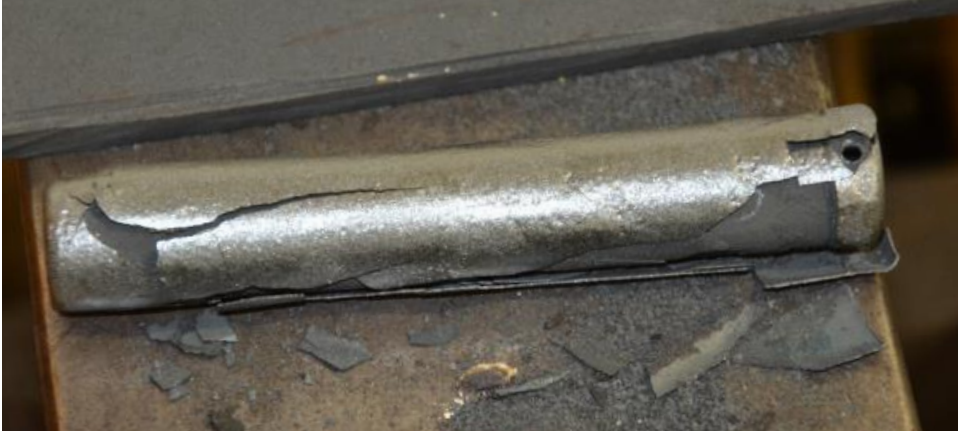
Figure 4.13. General view of sample No. 01 after a fire test at a temperature of 1300 ° C, visible strong oxidation of the surface and delamination of the top layer of the outer casing

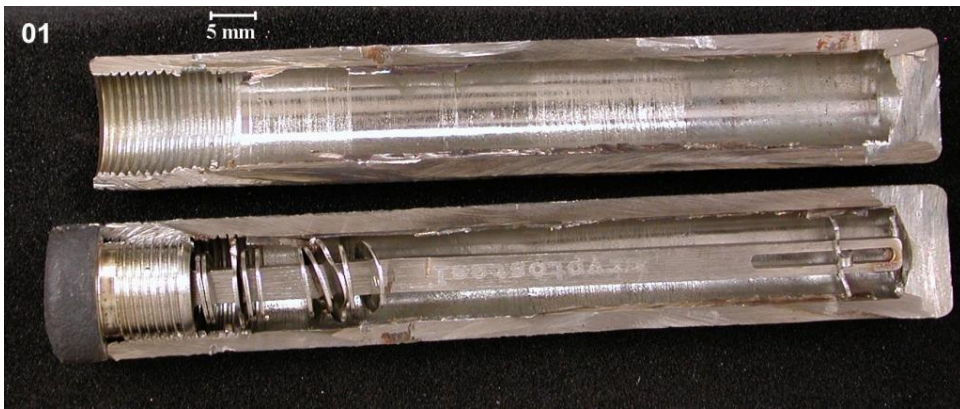
Figure 4.14. General view of the sample core No. 01, the thermally deformed pin, tiles, and separators undamaged

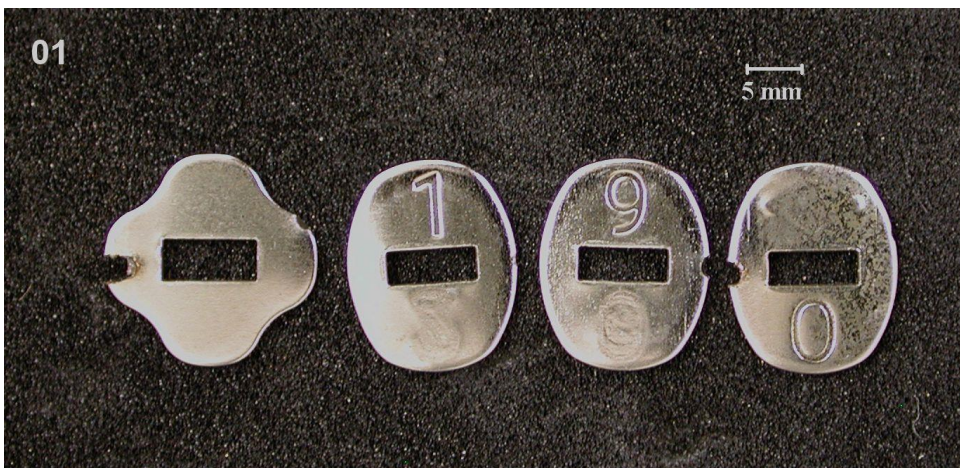
Figure 4.15. Tiles from the core of sample No. 01, no thermal changes in the material, visible embossed letters and numbers

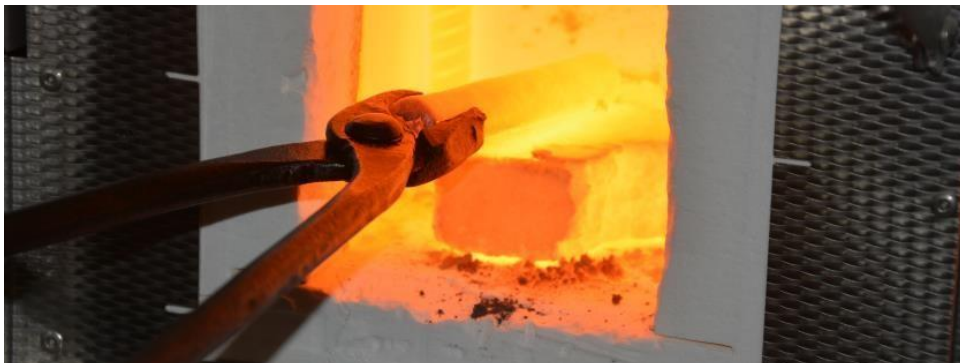
Figure 4.16. General view of sample No. 04 in a furnace at 1350 ° C

The laboratory fire test of the Cryptosteel capsule No. 04 was carried out at 1350 ° C for 60 minutes (Figs. 4.16 and 4.17). Macroscopic observations immediately after the fire test showed that the capsule surface was strongly oxidized and the surface layer delaminated (Fig. 4.18). Moreover, it was found that it was impossible to open the sample by unscrewing the nut, it was necessary to use a cutter. Observations of the capsule core showed thermal deformation of the pin, slight welding of the tiles, which gave way to the influence of mechanical pressure, and no thermal damage to the elements (fig. 4.19 and 4.20). It was possible to read the information written on the tiles inside the capsule (Fig. 4.21).

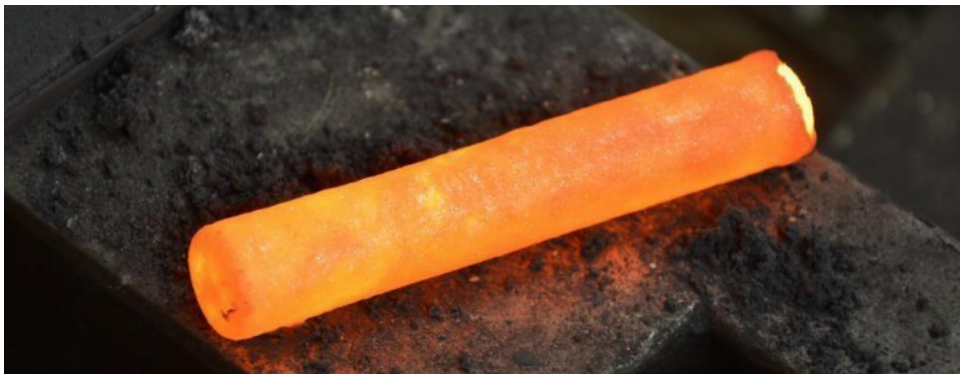
Figure 4.17. General view of sample No. 04 after removal from the furnace from the temperature of 1350 ° C

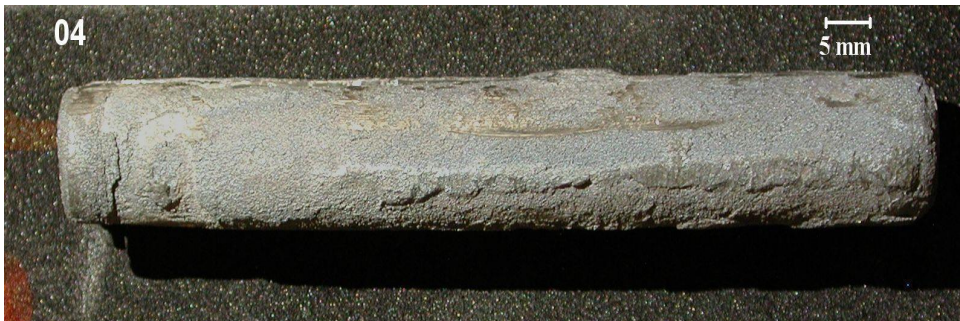
Figure 4.18. General view of specimen No. 04 after a fire test at 1350 ° C, visible strong oxidation of the surface and delamination of the top layer of the outer casing

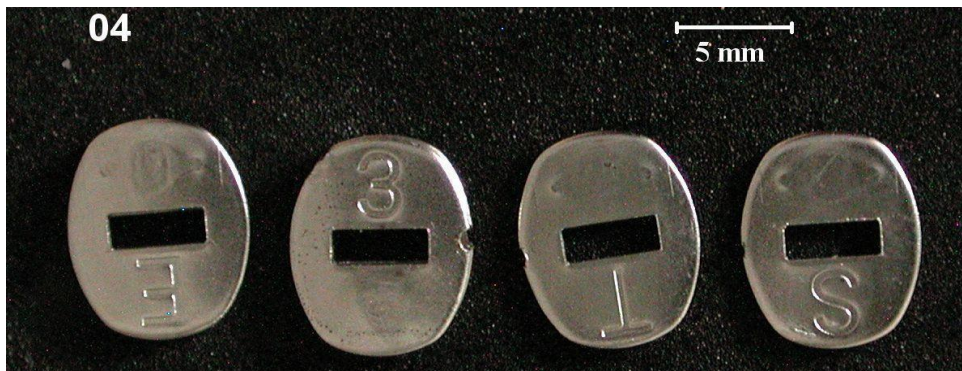
Figure 4.21. Tiles from the core of sample No. 04, no thermal changes in the material, visible embossed letters and numbers.

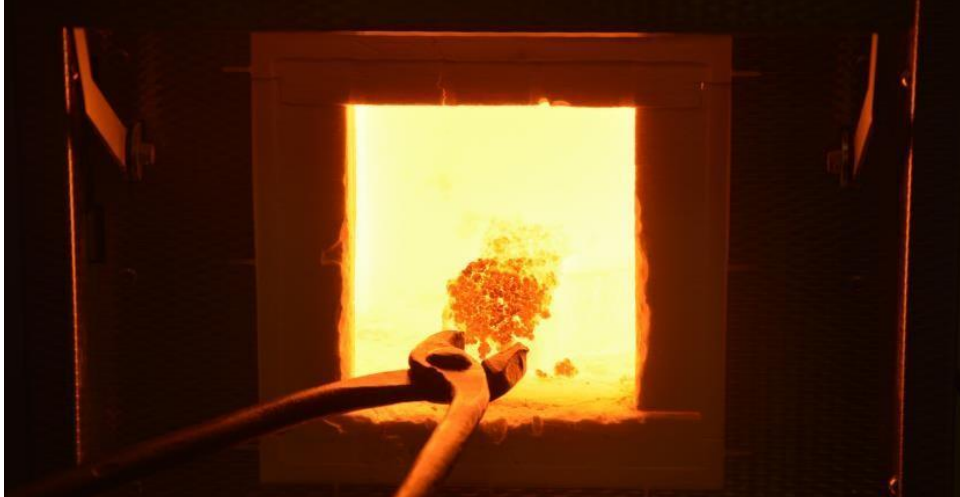
Figure 4.22. General view of sample No. 03 in a furnace at 1400 ° C

The laboratory fire test of the Cryptosteel capsule No. 03 was carried out at 1400 ° C for 60 minutes (Fig. 4.22). Macroscopic observations showed that the capsule material completely melts at this temperature (Figs. 4.23 and 4.24).

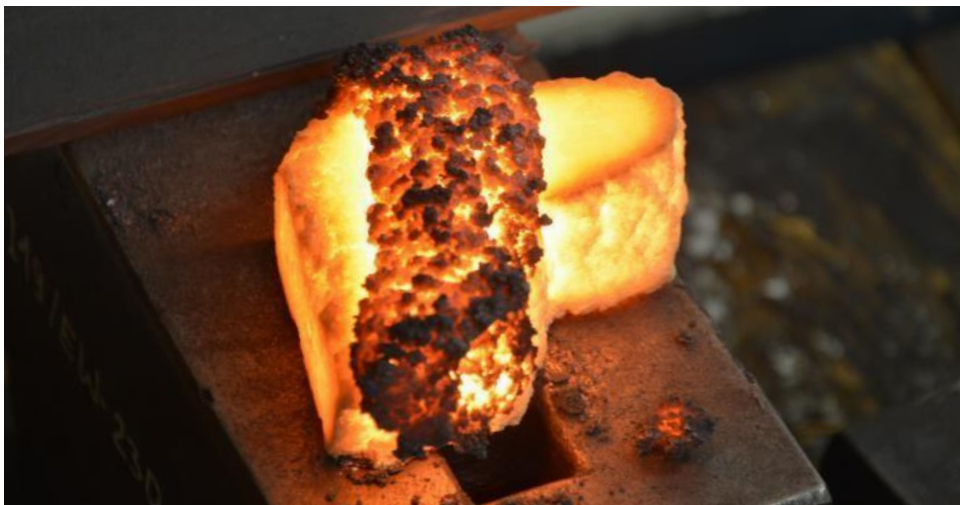
Figure 4.23. General view of sample No. 03 after its removal from the furnace at 1400 ° C

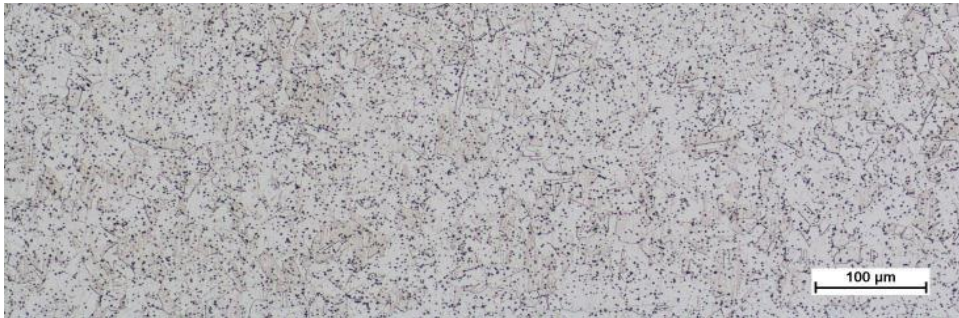
Figure 4.25. Sample material No. 02 after fire test at 1100 ° C, visible fine-grained structure typical of austenitic acid-resistant steel. Light microscopy, etched state.

Microscopic observations showed the presence of a structure typical of austenitic acid-resistant steel, confirming that AISI 303 stainless steel was used. The observed structure was fine-grained, i.e. there was no excessive and uncontrolled grain growth due to the high temperature applied. No negative influence of temperature on the mechanical properties of the element was shown. At the same time, a very large amount of chromium carbides was observed in the course of the research. The formation of carbides in the steel structure reduces the chromium content in the vicinity of the grain boundaries, changes the electrochemical potential, and thus reduces the corrosion resistance of the material.
